(12) **EUROPEAN PATENT APPLICATION**

(21) Application number: **96307759.9**

(71) Applicant: **ISUZU CERAMICS RESEARCH**
INSTITUTE CO., LTD.
Fujisawa-shi, Kanagawa-ken (JP)

(54) **Damage detecting apparatus for ceramic parts**

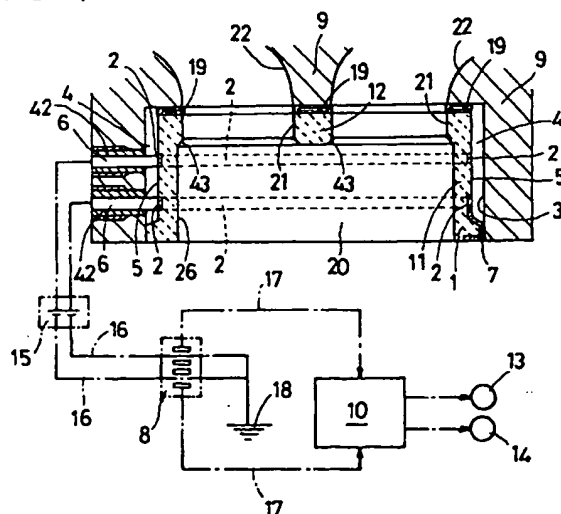
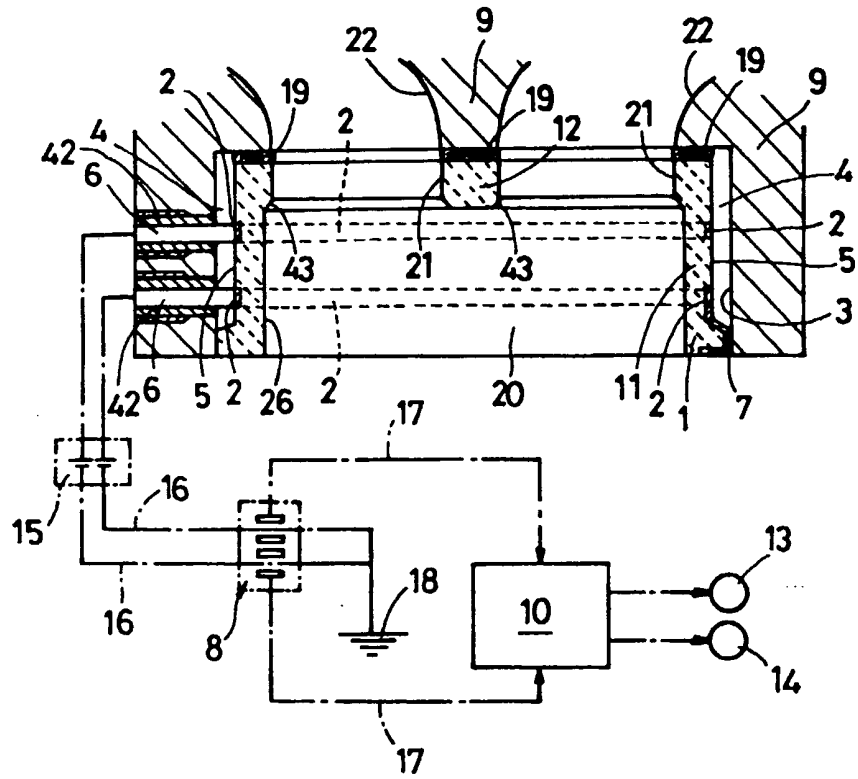
FIG. 1

Figure 1 and 2 show a first embodiment of this invention as applied to the head liner that forms a combustion chamber structure used in heat-insulated gas engines and heat-insulated engines. The damage detecting apparatus for ceramic parts includes a head liner 1 installed in a cavity 3 formed in the cylinder head 9 or cylinder block; wires 2 made of conductive ceramics and arranged to extend around an entire outer circumferential surface 5 of the head liner 1; a current detector 8 provided in lines 16 connected to connection terminals 6 of the wires 2; a battery 15 as a current feeding means for supplying a small current to the wires 2 through the lines 16 at all times or intermittently; and a controller 10 which, in response to a wire break detection signal from the current detector 8, turns on an alarm lamp 13 and stops the operation of a fuel pump 14 to stop the fuel supply to a main combustion chamber 20 as the combustion chamber. The current supply to the wires 2 from the battery 15 may be continuous or intermittent such as at certain intervals or periodically and the current sup-

(57) The damage detecting apparatus for ceramic parts detects breakage of the ceramic combustion chamber structure(1) and valves(150) or breakage and wear of the cylinder liner(125) and minimizes damage to the structure(1) and valves(150). The breakage of a head liner(1) forming the ceramic combustion chamber (20) can be detected by arranging conductive ceramic wires(2) on the outer circumferential surface (5) of the head liner(1) and passing a small current through those wires(2). The breakage of valves(150) installed in the ports(122) of a cylinder head(109) can be detected by

tion chamber structure with a damage detecting apparatus, in short, has the wires 2 arranged on the outer circumferential portion where cracks are likely to develop and insulated with the heat insulating air layer 4 or insulating film to detect the wire breakage state of the circumference of the head liner 1 and thus cracks and other damages to the head liner 1, if any.

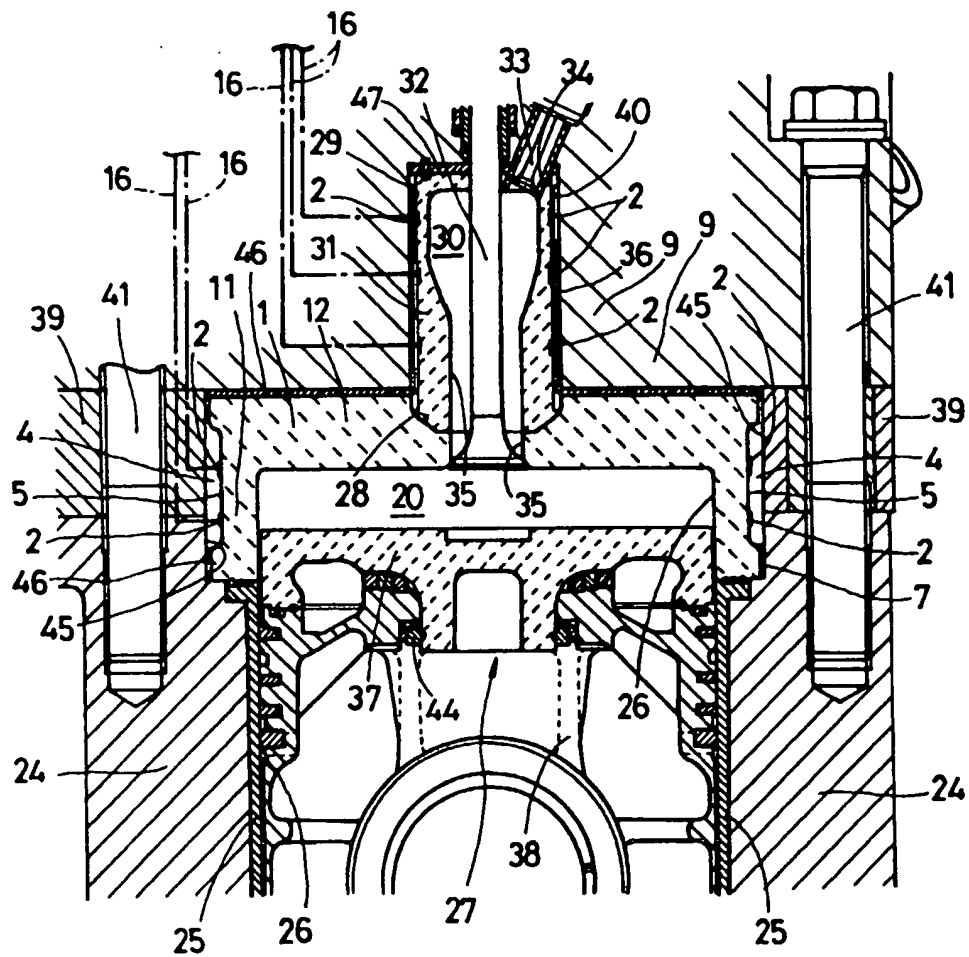
FIG. 3

Figure 3 is a cross section showing a second embodiment of the damage detecting apparatus for ceramic parts;

Next, by referring to Figure 3 the second embodiment of the damage detecting apparatus for ceramic parts will be described. This embodiment is applied to a heat-insulated engine such as heat-insulated gas engine and has the same construction as the first embodiment, except that the second embodiment has a sub-combustion chamber structure in the cylinder head. Identical components with those of the first embodiment are given like reference numerals and their explanations are not repeated here.

In the second embodiment, the combustion chamber structure includes the head liner 1 forming a main combustion chamber 20 and a sub-combustion chamber structure 31 forming a sub-combustion chamber 30 that communicates with the main combustion chamber 20 through a communication hole 35, and two or more spaced-apart wires 2 are installed on the outer circumferential surface 40 of the sub-combustion chamber structure. This heat-insulated engine therefore can detect a crack or break not only in the head liner 1 but also in the sub-combustion chamber structure 31 as the preceding embodiment detects a damage of the head liner 1. The sub-combustion chamber structure 31, like the head liner 1, is made of ceramics such as silicon nitride and silicon carbide.

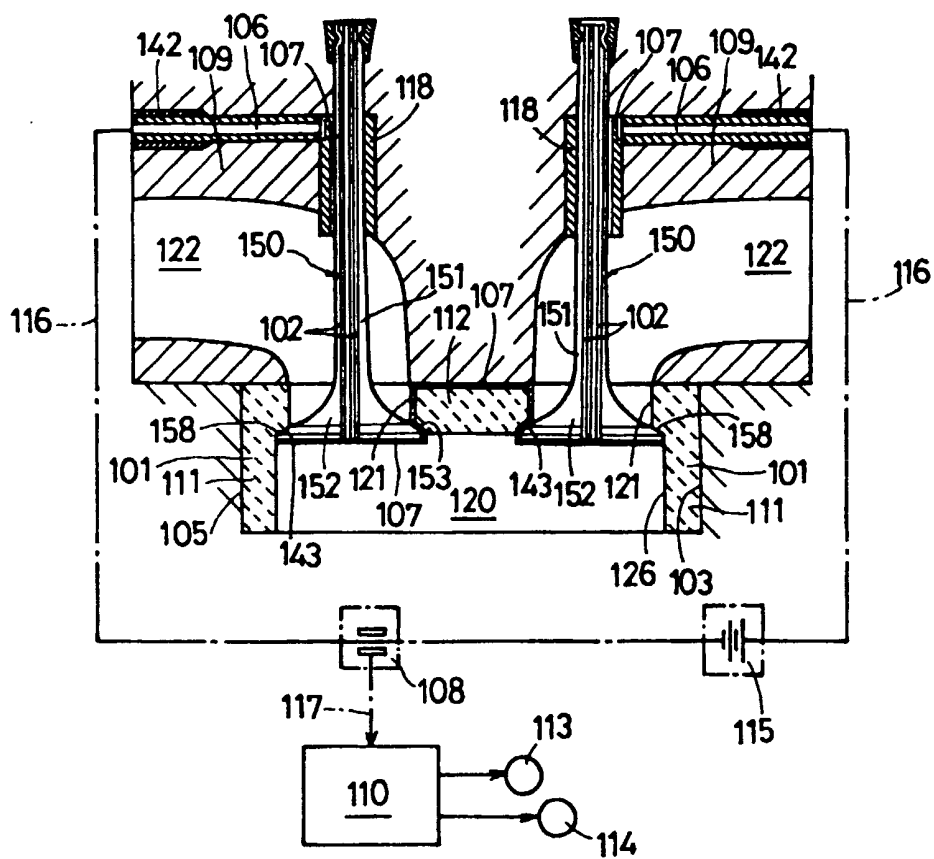
FIG. 4

Figure 4 is a schematic view showing a third embodiment of the damage detecting apparatus for ceramic parts;

Figure 4 and 5 show a third embodiment of the damage detecting apparatus for ceramic parts according to this invention as applied to valves incorporated in heat-

insulated gas engines and heat-insulated engines. The damage detecting apparatus for ceramic parts comprises: a head liner 101 installed in a cavity 103 formed in the cylinder head 109; valves 150 installed in ports 121 formed in the head liner 101; conductive lines 102 extending longitudinally along valve stems 151 of the valves 150; a current detector 108 provided in a line 116 connecting to connection terminals 106 of the conductive lines 102; a battery 115 as a current supply means to feed a small current to the conductive lines 102 through the line 116 continuously or intermittently; and a controller 110 which, in response to a wire break signal from the current detector 108, turns on an alarm lamp 113 and stops a fuel pump 114 to stop the fuel supply to the main combustion chamber 120. The current supply to the conductive lines 102 from the battery 115 may be continuous, or intermittent such as at predetermined intervals or periodically, and the current supply condition can be detected by the current detector 108.

In the damage detecting apparatus for ceramic parts, the conductive lines 102 provided in the valve stem 151 are formed of SiC fibers applied with a conductive material inside the valve stem 151. While Figure 4 shows two conductive lines 102 in each valve stem 151, a single wire or three or more may be installed, spaced apart. The conductive layer forming the conductive lines 102 is an SiC layer impregnated or coated with

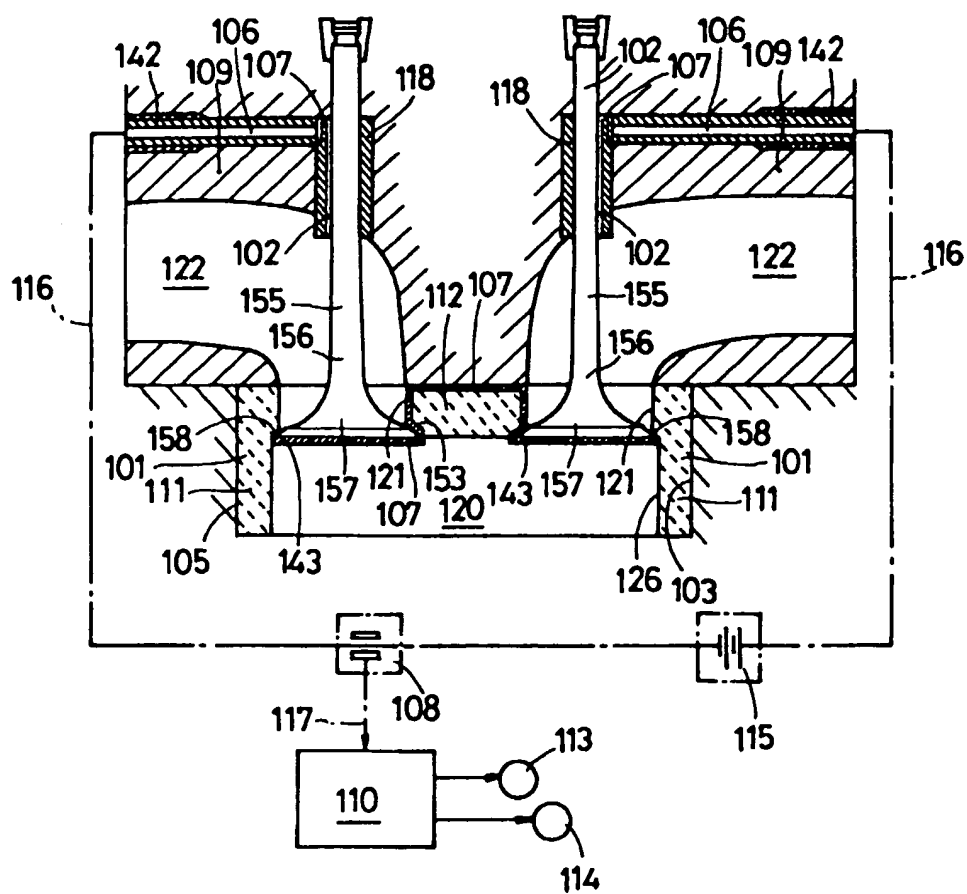
FIG. 6

Figure 6 is a cross section showing a fourth embodiment of the damage detecting apparatus for ceramic parts;

Next, by referring to Figure 6, a fourth embodiment of the damage detecting apparatus for ceramic parts according to this invention will be described. The fourth embodiment is similar to the preceding embodiment of Figure 4 except that the valve itself is made of a conductive material. Identical components are assigned the same reference numbers as in Figure 4. In this embodiment, the conductive lines 102 provided to the valve stem 156 of the valve 155 are made by forming the valve 155 of a material which is SiC fibers impregnated or coated with a conductive material containing at least one of TiC, ZrC, WC, TiN, ZrB₂, TiB₂, HfB₂, NbB₂ and TaB₂. The valve 155 is formed as a one-piece structure having a valve stem 156 and a valve head 157. In this embodiment, there is no need to provide a conductive coating layer to the valve face 158 as in the embodiment of Figure 4, because the valve face 158 is conductive.

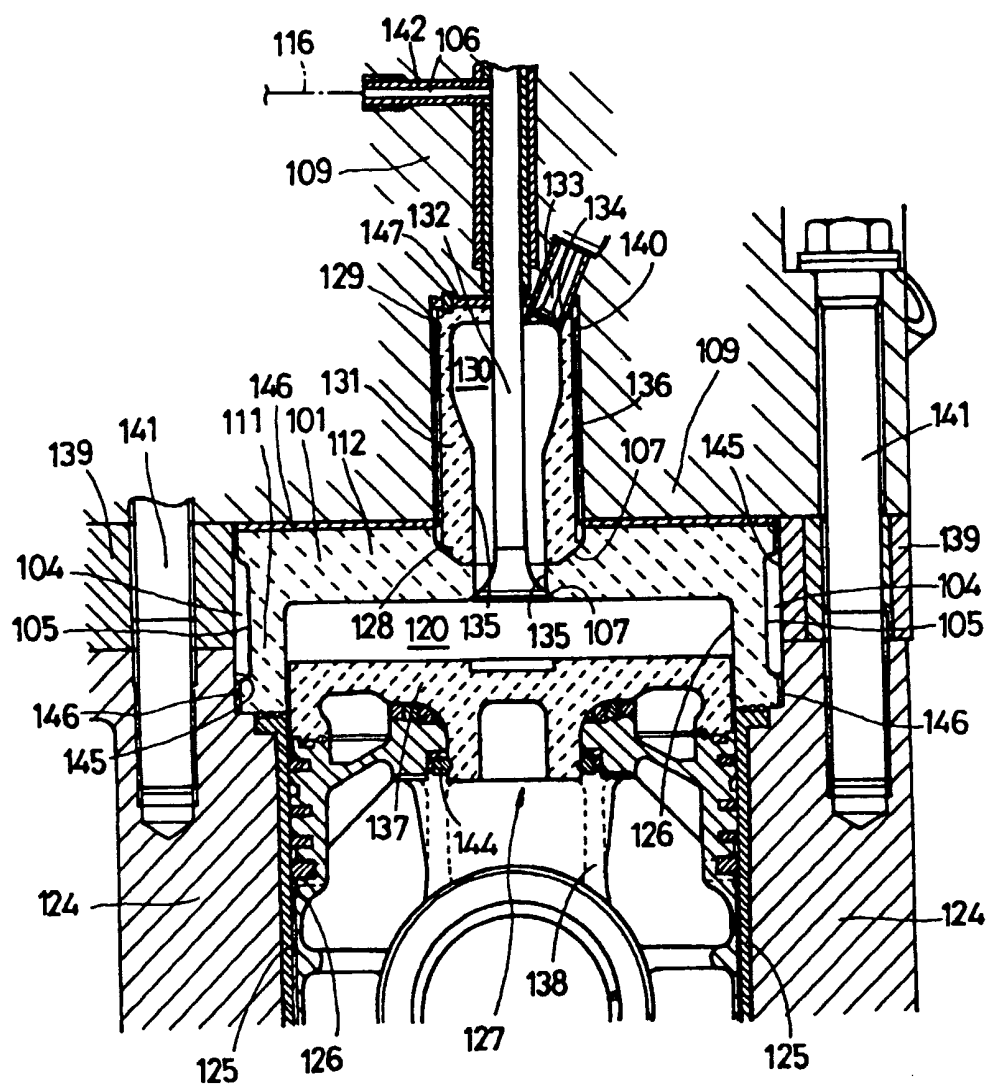
FIG. 7

Figure 7 is a cross section showing a fifth embodiment of the damage detecting apparatus for ceramic parts;

By referring to Figure 7, let us explain about a fifth embodiment of the damage detecting apparatus for ceramic parts. This embodiment concerns a case where this invention is applied to a communication hole valve of the heat-insulated gas engine while the preceding embodiments concern applications to the intake and exhaust valves. The construction of the valve itself is identical with those of the preceding embodiments, so the cor-

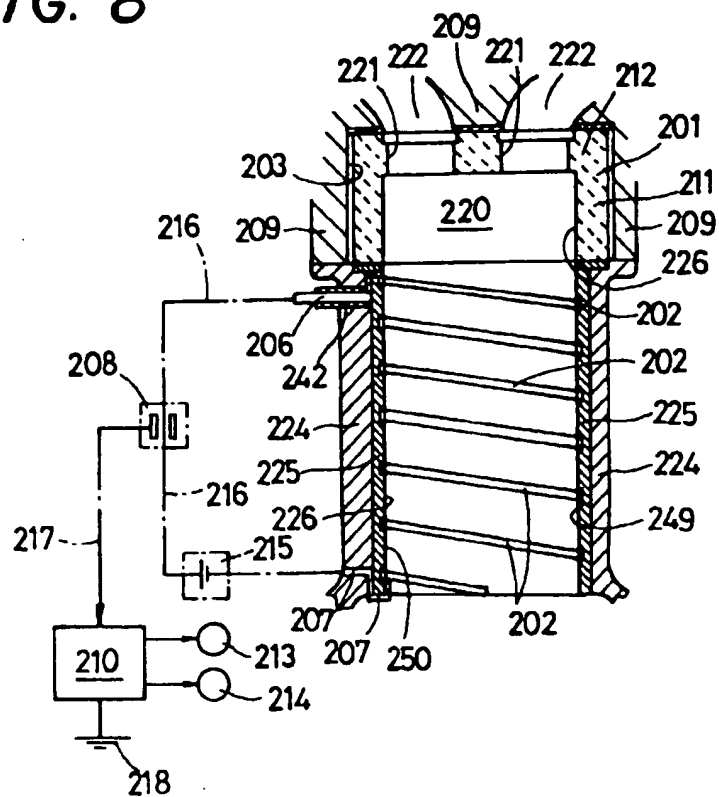
FIG. 8

Figure 8 is a schematic view showing a sixth embodiment of the damage detecting apparatus for ceramic parts;

Figure 8 shows a sixth embodiment of the damage detecting apparatus for ceramic parts of this invention as applied to valves incorporated in the heat-insulated gas engines or heat-insulated engines. The damage detecting apparatus for ceramic parts comprises: a head liner 201 installed in a cavity 203 formed in the cylinder head 209; a port 221 formed in the head liner 201; a cylinder block 224 mounted to the cylinder head 209; a cylinder liner 225 made of a ceramic material and installed in the hollow portion 249 of the cylinder block 224; a conductive line 202 extending in the longitudinal

In the damage detecting apparatus for ceramic parts, the conductive line 202 provided to the cylinder liner 225 is made by forming on the inner wall surface 250 of the cylinder liner 225 made from Si_3N_4 a conductive layer of a conductive material. While Figure 8 shows the conductive line 202 to extend spirally from the terminal 206 at the upper end of the cylinder liner 225 to the terminal 207 at the lower end, it is possible to use one line or three or more lines 202. The conductive line 202, instead of extending spirally, may run linearly from the upper end of the cylinder liner 225 to the lower end. Further, the conductive layer of the conductive line 202 provided to the inner wall surface 250 of the cylinder liner 225 can be changed in depth according to the level of wear of the cylinder liner 225. It may be formed deep where the cylinder liner 225 is subject to heavy wear and shallow where it is subject to light wear.

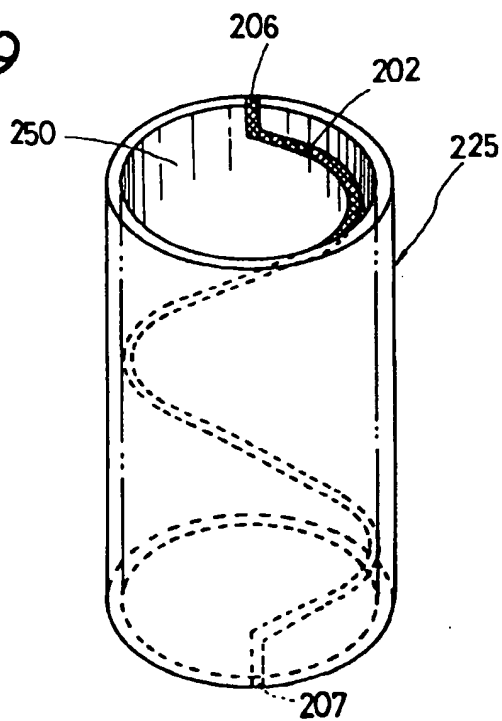
FIG. 9

Figure 9 is a perspective view showing a seventh embodiment of the damage detecting apparatus for ceramic parts;

Next, by referring to Figure 9, a seventh embodiment of the damage detecting apparatus for ceramic parts according to this invention is explained. The embodiment of Figure 7 is similar to the preceding embodiment of Figure 8 except that the shape of the conductive line provided to the cylinder liner differs from that of the preceding embodiment. Components identical with those of the preceding embodiment are given like reference numerals. The damage detecting apparatus for ceramic parts of this embodiment has formed on the inner wall surface 250 of the cylinder liner 225 with a spiral conductive line 202 with a long lead.

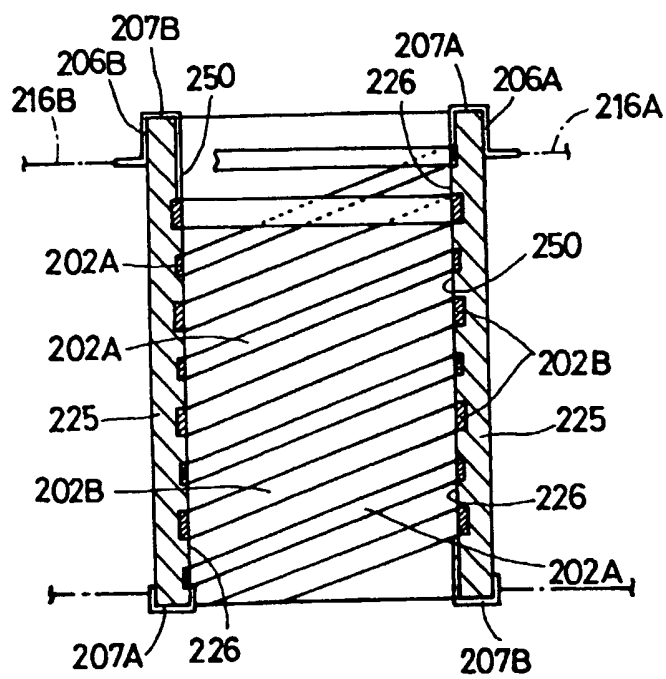
FIG. 10

Figure 10 is a cross section showing an eighth embodiment of the damage detecting apparatus for ceramic parts; and

By referring to Figure 10, the eighth embodiment of the damage detecting apparatus for ceramic parts according to this invention will be explained. The eighth embodiment is similar to the preceding embodiment of Figure 8 except that the valve itself is made of a conductive material and its components identical with those of Figure 8 are assigned like reference numerals. In this embodiment, a number of spiral conductive lines 202A, 202B (in the case of Figure 10, two lines) with differing thicknesses or depths are formed on the inner wall surface 250 of the cylinder liner 225. The conductive lines 202A, 202B are connected to the lines 216A, 216B, respectively, so that any line break can be detected independently by the current detector 208. The conductive lines 202A, 202B are connected at one end, through connection terminals 206A, 206B, to the lines 216A, 216B, which are provided with the current detector 208. The other ends of the conductive lines 202A, 202B are connected through the connection terminals 207A, 207B to the cylinder block that serves as a ground. Hence, this embodiment allows the amount of wear of the cylinder liner 225 to be detected, making it possible to predict the life span of the cylinder liner 225 and to perform maintenance appropriately and easily, such as replacement of the cylinder liner 225.

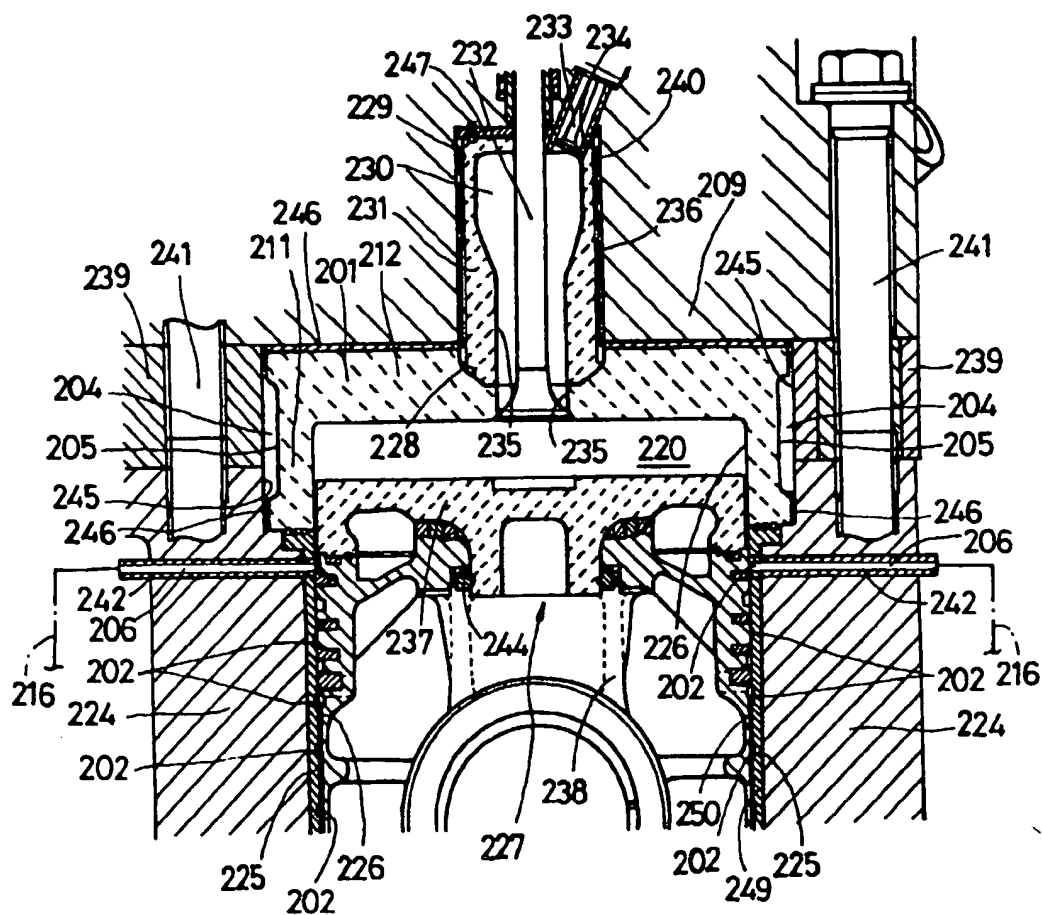
FIG. 11

Figure 11 is a cross section showing a ninth embodiment of the damage detecting apparatus for ceramic parts.

Further, by referring to Figure 11, a ninth embodiment of the damage detecting apparatus for ceramic parts is described. The ninth embodiment concerns a case where the cylinder liner of the preceding embodiments is applied as the cylinder liner in the heat-insulated gas engine. The cylinder liner itself has the same construction and function as those of the preceding embodi-

This embodiment is characterized in that the conductive line 202 is arranged on the cylinder liner 225 installed in a hollow portion 249 formed in the cylinder block 224. The conductive line 202 provided to the cylinder liner 225 has the same construction and function as the conductive line 202, 202A or 202B of the preceding embodiments. Hence, when the cylinder liner 225 develops any damages such as cracks, scores or breaks, the conductive line 202 can immediately detect them. If the conductive lines 202 with different depths (202A or 202B of Figure 10) are formed on the cylinder liner 225, it is possible to detect the amount of wear of the cylinder liner 225.
